# What colour was that?

## The repaint of Newcastle 114

Liveries and the accuracy of their recreations always arouse considerable controversy throughout the railway preservation movement. **Paul Jarman** recounts the trials and tribulations of getting the paint job on a Newcastle tramcar exactly right.

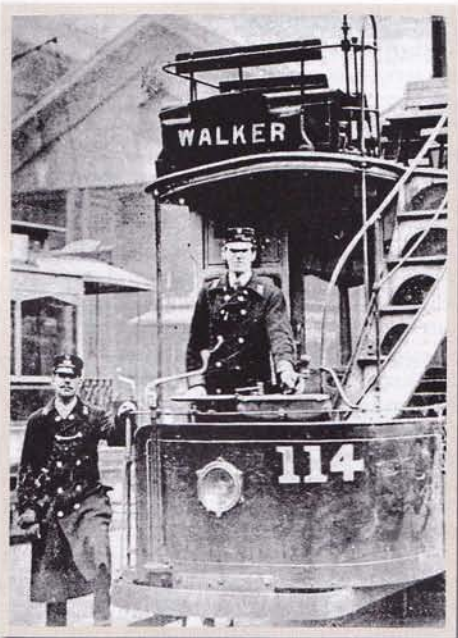
A view of 114 taken in Newcastle and showing the dirt accumulated on the dash panel.

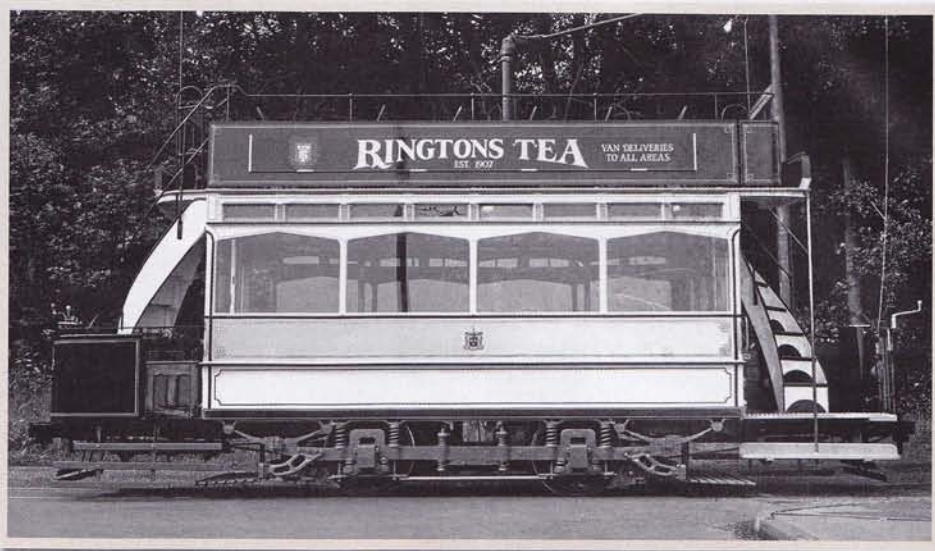
This side view of 114, taken after its repaint, uses a panchromatic negative and shows the bright waist panel (with crest on), contrasting with the dark dash panels at each end.

Finally, a photograph of 114 immediately after its rebuild with canopies and top cover shows quite clearly the waist panels to be a lighter shade to the dash panels. While there was an intermediate livery style in Newcastle, to see it directly applied to 114 is useful evidence to argue that it was probably a partial repaint when rebuilt (as it was only five or six years old) and that the waist panels were indeed a different colour to the dash panels.

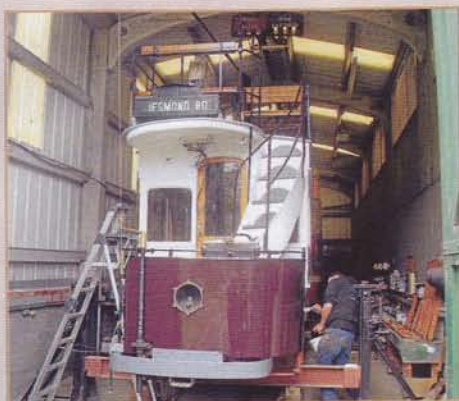
114 being repainted, with the dash panels having received their first coats of colour.

To carry out 114's repaint Beamish called upon the services of coachpainter and signwriter Phil Anderson (who carried out the stunning repaint of the NRM's J52 and 'Crab' locomotives). His superb work on Blackpool 31 tram at Beamish and his attention to detail were exactly what this project needed. Fortunately 114's body was in sound condition and was rapidly rubbed down and prepared for painting. Once in primer we looked at various shades of 'cadmium yellow' which has such a distinctive orange characteristic that it took some time to settle on a shade (BR warning panel yellow being suspiciously similar incidentally). At this stage there was no going back and as Phil applied each colour and built up the finish I felt more confident that this was the right thing to do! The brown/maroon/plum colour was mixed by Phil with a strong content of Midland Railway crimson in the tin. A shade that fitted descriptions was arrived at and applied and manages to look brown or maroon depending on who is describing it! Lining and varnishing followed and 114 was duly rolled out for commissioning in the early summer.

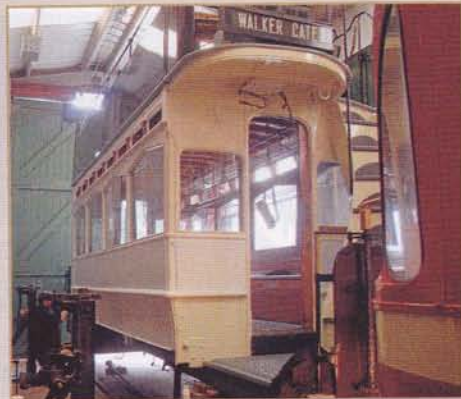
This view shows 114 lifted clear of its truck and in primer awaiting application of the new colour scheme.

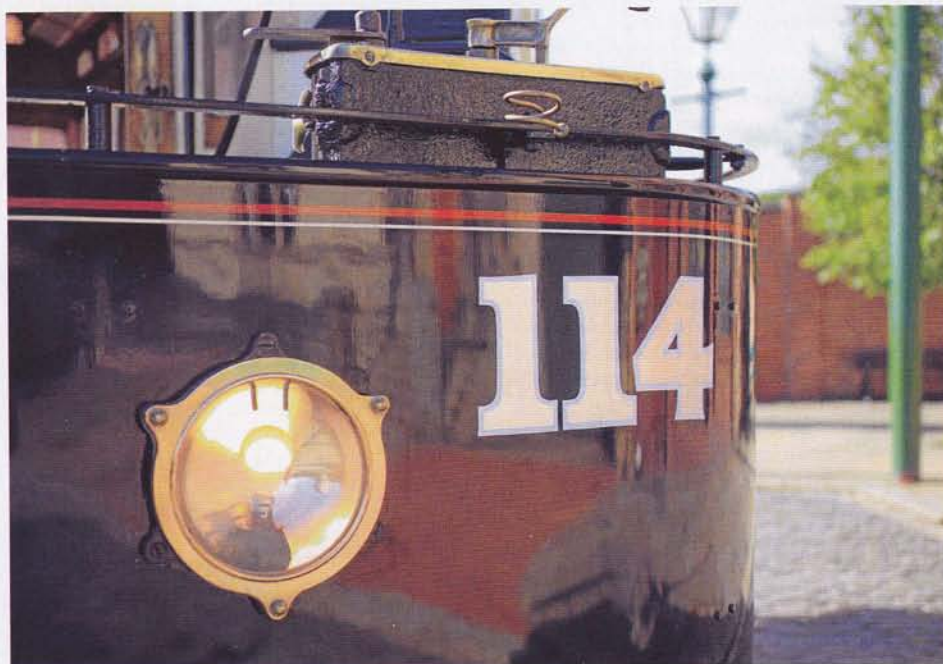
A close up 114's dash panel.

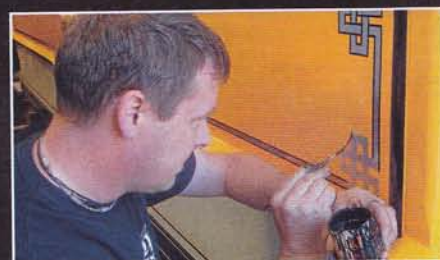
Phil Anderson applies the black edging to the silver lining on the waist panel of 114.

Lining was ornate and included triple Greek Keys at the corners on the waist panels and was aluminium edged with black lines. Gold and silver were found to be unsuitable in the arduous service conditions of a heavily polluted industrial city. The brown dashes were lined yellow and red and black lining was used around the windows. Floor and roof were battleship grey, staircase treads and handrails maroon, top deck handrails black and the inner sides of the dash panels were khaki. Trucks, lifeguards and trays were maroon.

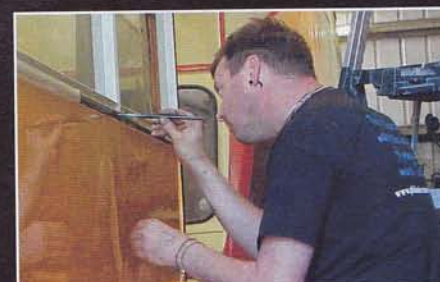
Phil picks out the beading below the windows on 114. Such work transforms the appearance but is extremely time consuming!
